Contract #: 04-0120F4Cty: SF/ALA Rte: 80 PM: 13.2/13.9File #: 69.28**WELDING INSPECTION REPORT****Resident Engineer:**Siegenthaler, Peter**Address:** 333 Burma Road**City:** Oakland, CA 94607**Report No:** WIR-021601**Date Inspected:** 02-Mar-2011**Project Name:** SAS Superstructure**OSM Arrival Time:** 700**Prime Contractor:** American Bridge/Fluor Enterprises, a JV**OSM Departure Time:** 1900**Contractor:** Zhenhua Port Machinery Company, Ltd (ZPMC), Changxing Island **Location:** Shanghai, China**CWI Name:** Mr. Xu Le Feng.**CWI Present:** Yes No**Inspected CWI report:** Yes No N/A**Rod Oven in Use:** Yes No N/A**Electrode to specification:** Yes No N/A**Weld Procedures Followed:** Yes No N/A**Qualified Welders:** Yes No N/A**Verified Joint Fit-up:** Yes No N/A**Approved Drawings:** Yes No N/A**Approved WPS:** Yes No N/A**Delayed / Cancelled:** Yes No N/A**Bridge No:** 34-0006**Component:** Tower and Orthotropic Box Girder (OBG)**Summary of Items Observed:**

WELDING INSPECTION REPORT

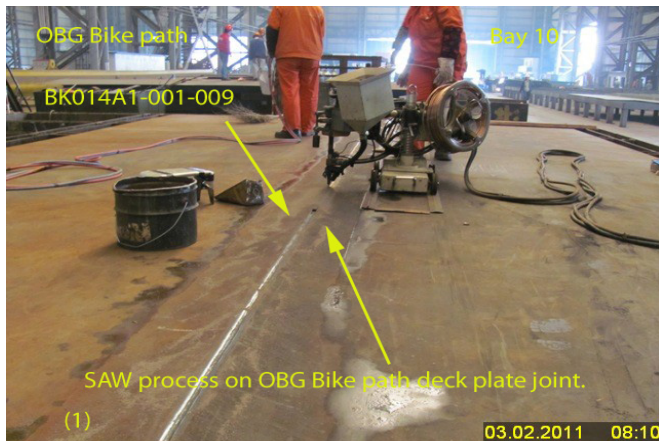
This QA Inspector observed ZPMC qualified welding personnel identified as 207745 Perform Submerged Arc Welding (SAW) on OBG Bike path. Joint identified as BK014A1-001-009. ZPMC CWI Identified as QC Lijun. The welding parameters as measured using QC's calibrated instrument appeared to be in general compliance with WPS-B-T-2221-L2c-S-2. For more information see attached picture number 1.

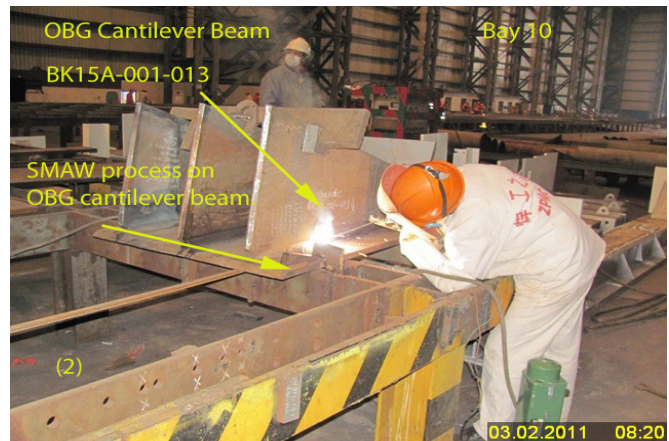
This QA Inspector observed ZPMC qualified welding personnel identified as 040365 Perform Shielded Metal Arc Welding (SMAW) on OBG Cantilever beam. Joint identified as BK15A-001-013. ZPMC QC Identified as Yun Chang Fang. The welding parameters as measured using QC's calibrated instrument appeared to be in general compliance with WPS-B-P-2212-Tc-U4c. For more information see attached picture number 2.
